This is your electronic confirmation for the electronic filing of meeting minutes for the Kent County Water Authority. The meeting minutes filed are in for the meeting held on: November 15, 2012 15:30:00.

On August 30, 2012 Acuren representatives, Bill Iaquessa and Matt Weaver performed a condition assessment of the exterior and interior of a welded steel ground storage water tank for the KCWA. The inspection was conducted to establish the current condition of the tank's coatings, steel substrate, safety and sanitary equipment.

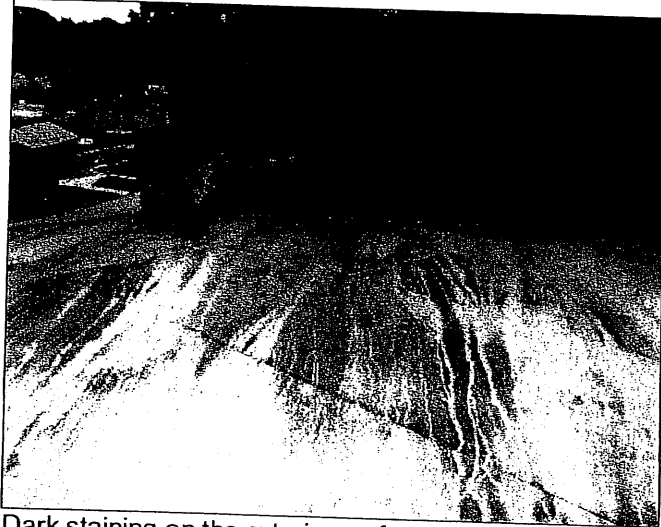
DP#17

Dark staining on the exterior roof

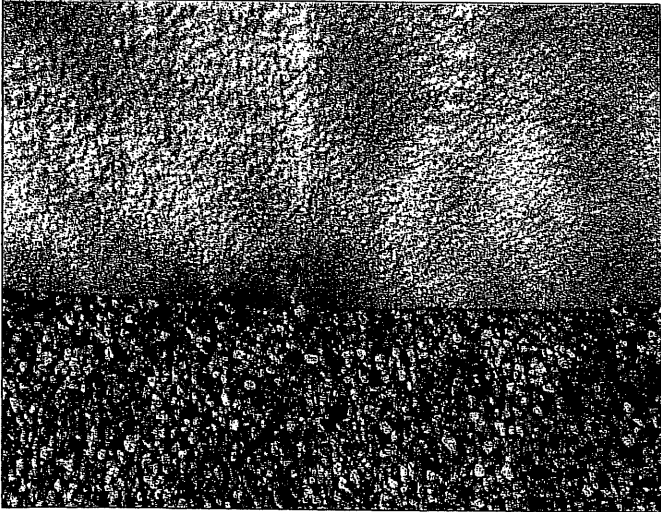
DP#11

Surface crack on the shell

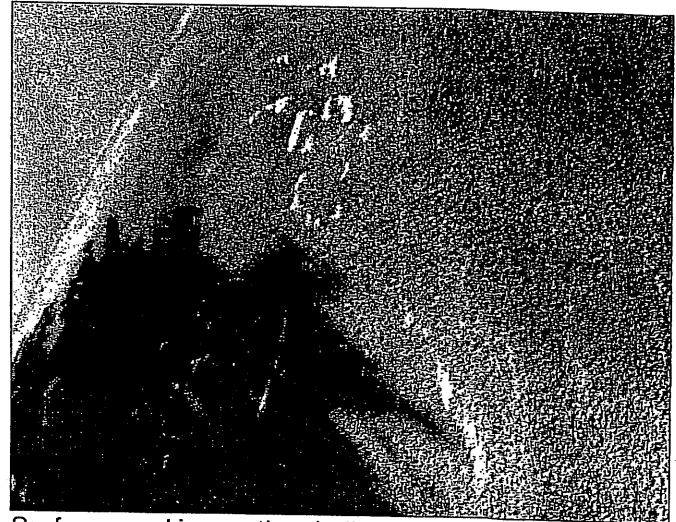
DP#4

Surface cracking on the shell with efflorescence
