This is your electronic confirmation for the electronic filing of meeting minutes for the Kent County Water Authority. The meeting minutes filed are in for the meeting held on: November 15, 2012 15:30:00.

On August 30, 2012 Acuren representatives, Bill Iaquessa and Matt Weaver performed a condition assessment of the exterior and interior of a welded steel ground storage water tank for the KCWA. The inspection was conducted to establish the current condition of the tank's coatings, steel substrate, safety and sanitary equipment.

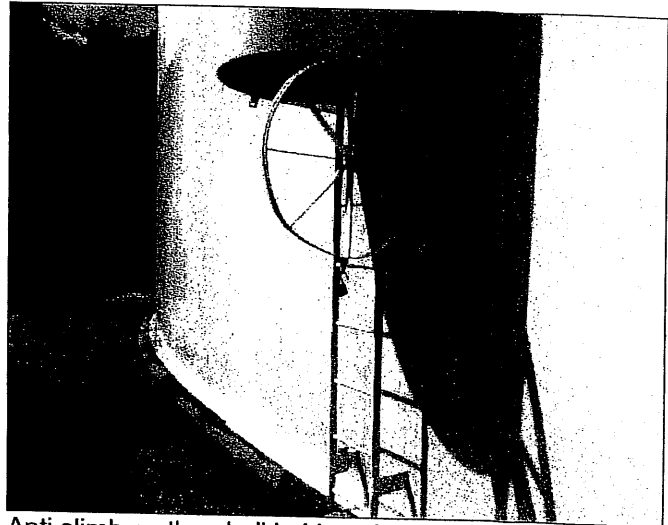
DP#4

Anti climb on the shell ladder with a lock

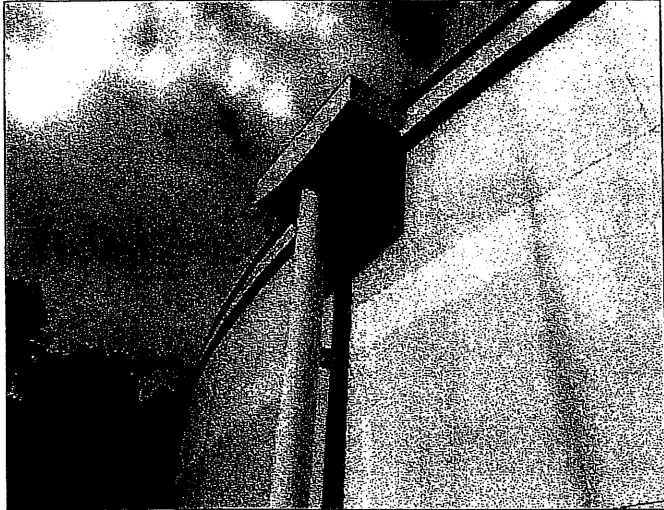
DP#5

Overflow pipe with an exterior weir box

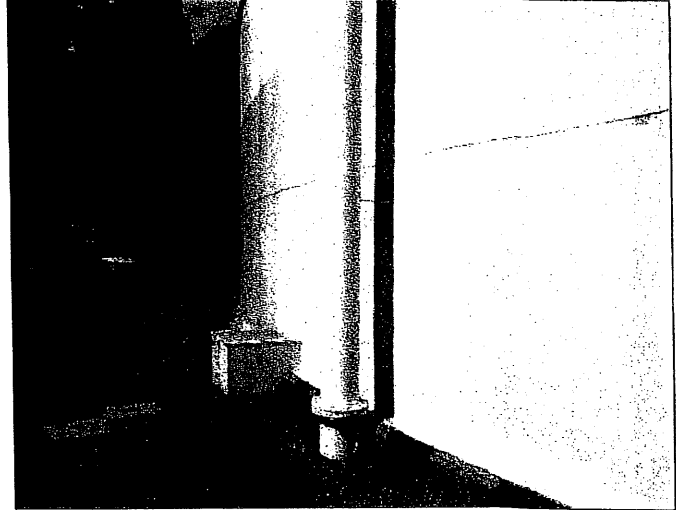
DP#6

Overflow pipe enters into the ground

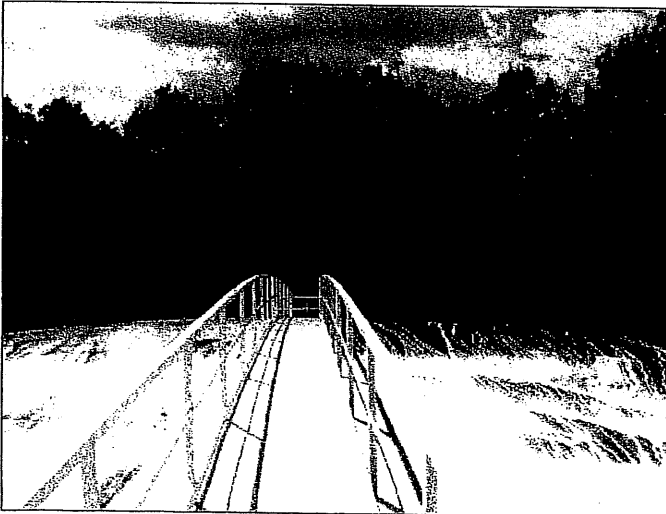
DP#15

Center roof with balcony and safety railing

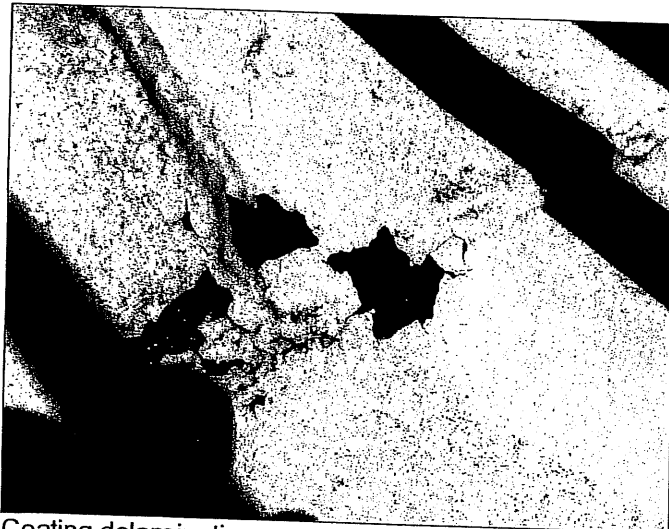
DP#19

Coating delamination on a roof plate edge

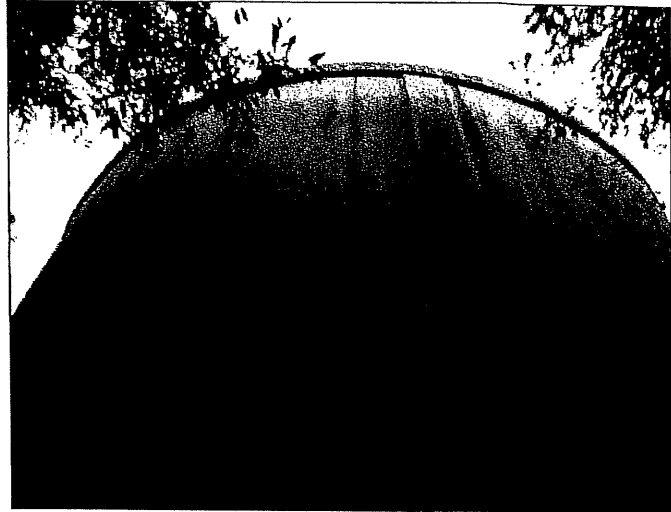
DP#4

Mildew growth on the exterior shell

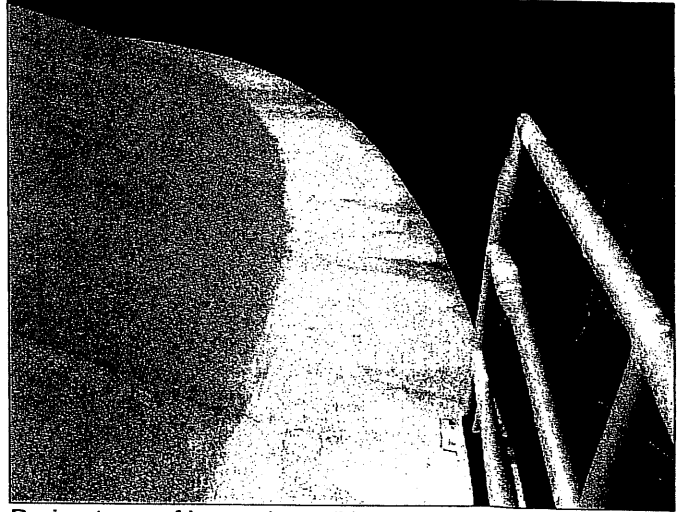
DP#22

Perimeter roof in good condition

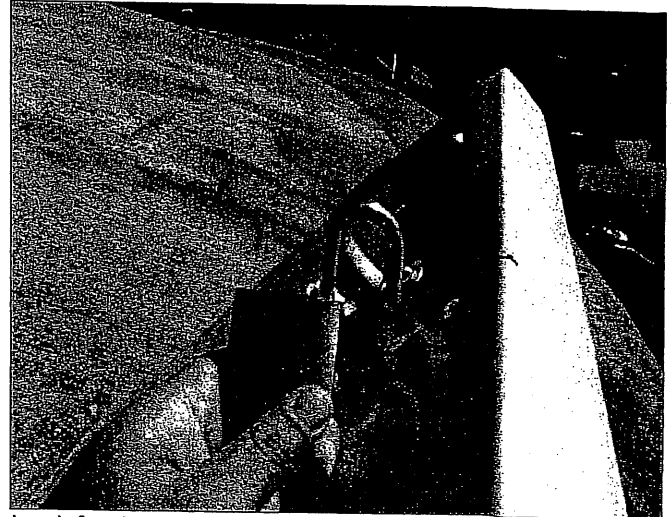
DP#20

Lock for the perimeter roof hatch
