This is your electronic confirmation for the electronic filing of meeting minutes for the Kent County Water Authority. The meeting minutes filed are in for the meeting held on: November 15, 2012 15:30:00.

On August 30, 2012 Acuren representatives, Bill Iaquessa and Matt Weaver performed a condition assessment of the exterior and interior of a welded steel ground storage water tank for the KCWA. The inspection was conducted to establish the current condition of the tank's coatings, steel substrate, safety and sanitary equipment.

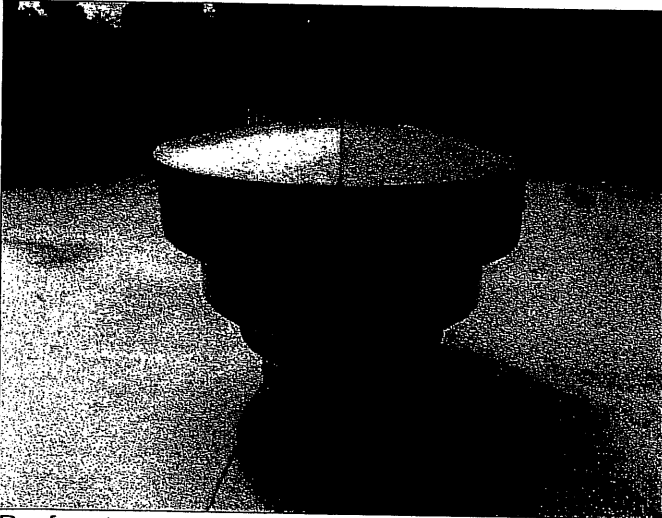
DP#23

Roof vent

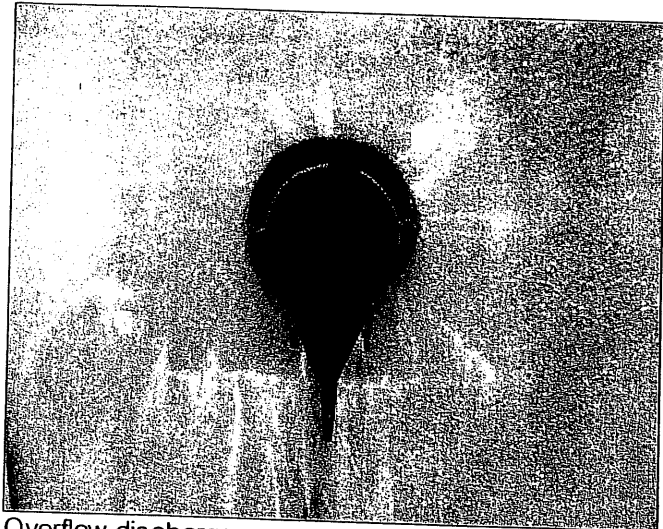
DP#5

Overflow discharge

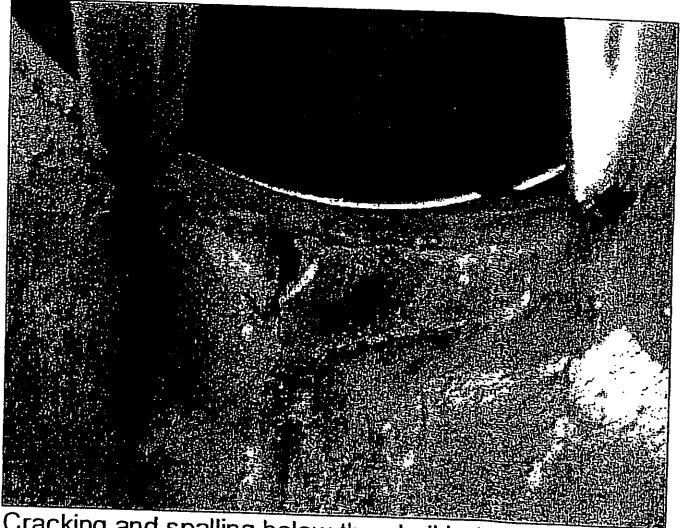
DP#6

Cracking and spalling below the shell hatch
